EFFECT OF ENBRITTLED 110-18 WELD METAL
on the
FATIGUE LIFE OF HY-80 STEEL BUTT WELDMENTS
Lab. Project 9300-1, Technical Memorandum 2
SR 007-01-01, Task 0856

17 October 1963

MATERIAL SCIENCE DIVISION

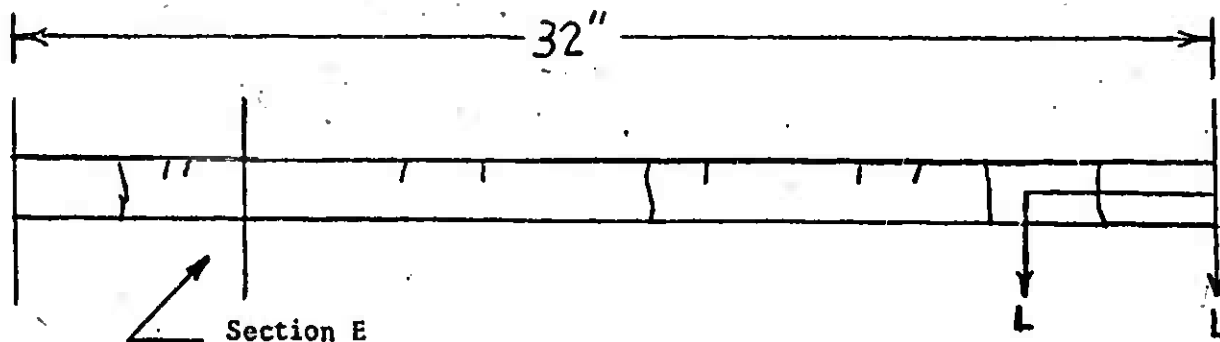
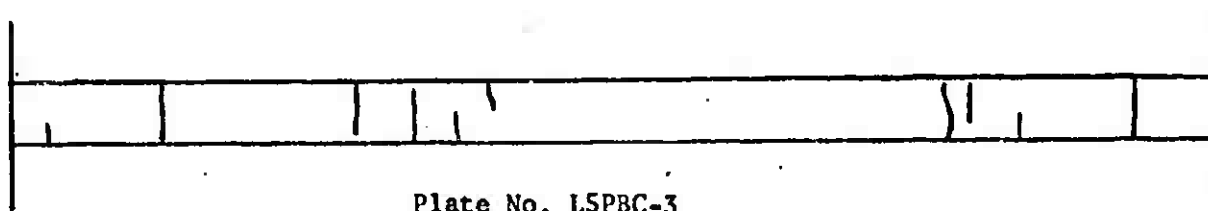
Fig. 1 - Location of Major Cracks Prior to Fatigue Testing

7. Prior to fatigue testing, each weldment was examined by magnetic particle and X-Ray methods. The location, size, direction and extent of major cracks, associated with the embrittled weld metal, are indicated in Figure 1.

9. As indicated in Figure 1, the cracks associated with the embrittled weld layer prior to fatigue testing, were transverse. Accordingly, crack depth and spacing are evident in the longitudinal macrosection (LL) shown in Figure 4. The fatigue crack is not shown in this view. Figure 5 indicates the orientation of macrosections selected from specimen LS PBC-2 after fatigue testing. Photographs of these macrosections are shown in Figure 6. The macrosections taken at a 45° angle (B-B, C-C, D-D) illustrate the relationship between embrittlement and fatigue type cracks. Since the embrittlement cracks were transverse, the parallel transverse macrosection (A-A) only exhibits the fatigue crack.

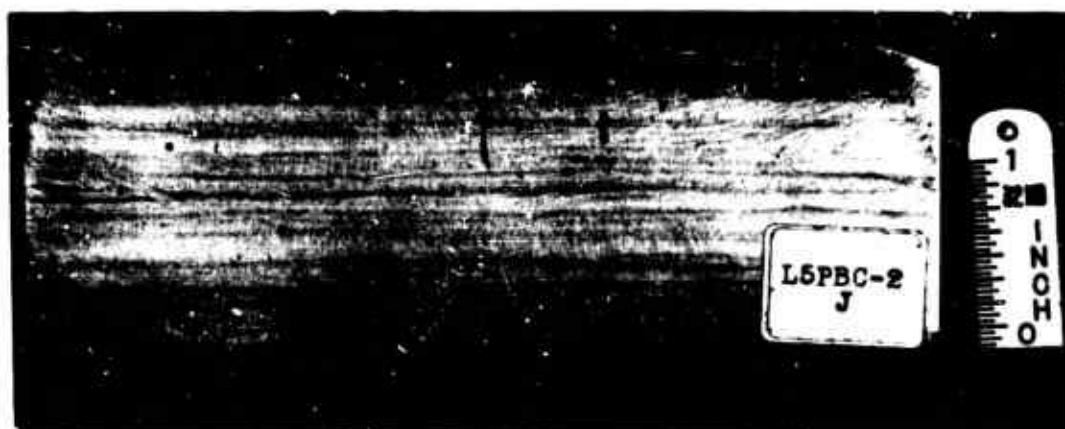
Fig. (4) Macrograph of Embrittled Butt Weldment L5PEC-2
After Fatigue Testing

Longitudinal Section L-L of Fig. (1)

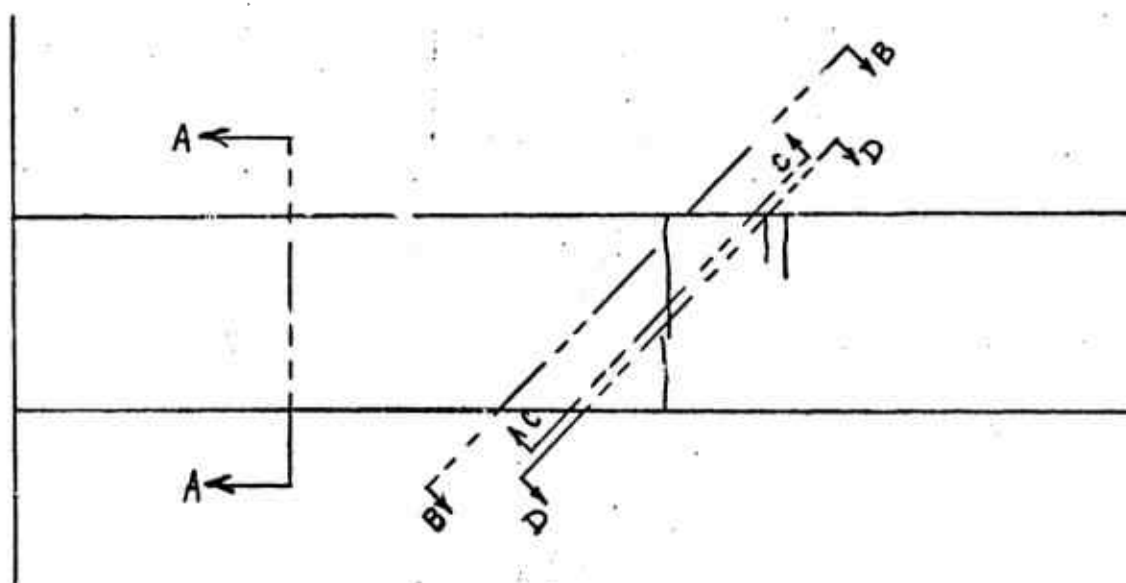
Fig. 5 - Location of 45° Transverse Macro Section Taken From Embrittled Weldment After Fatigue Testing

Enlarged View of Section E of Fig (1)

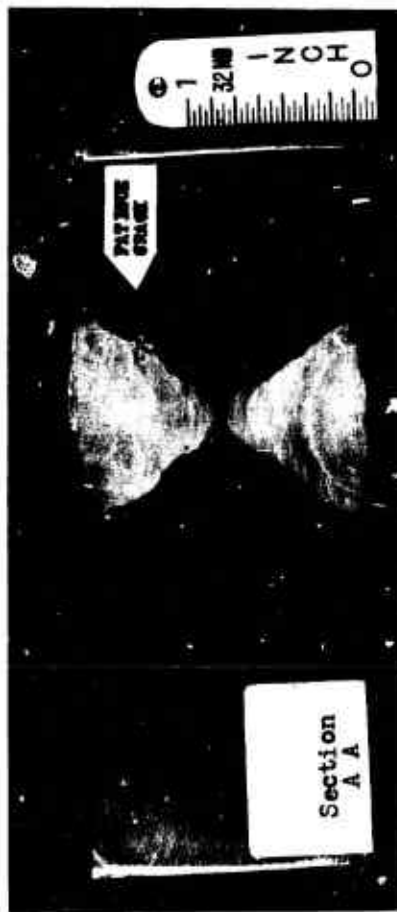
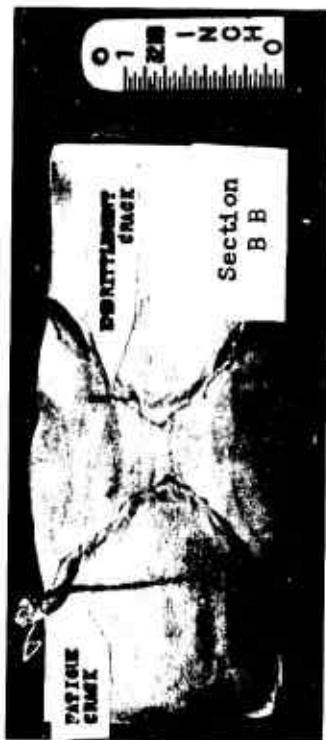
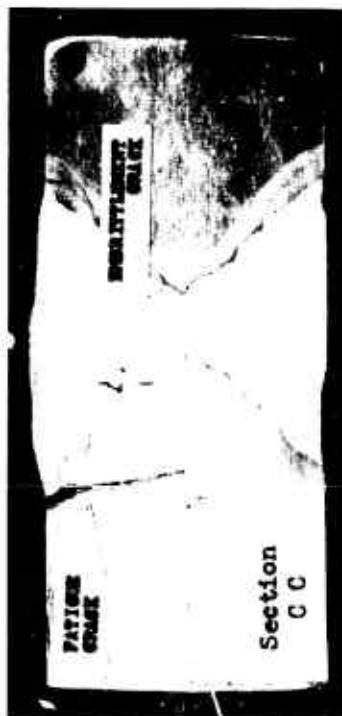
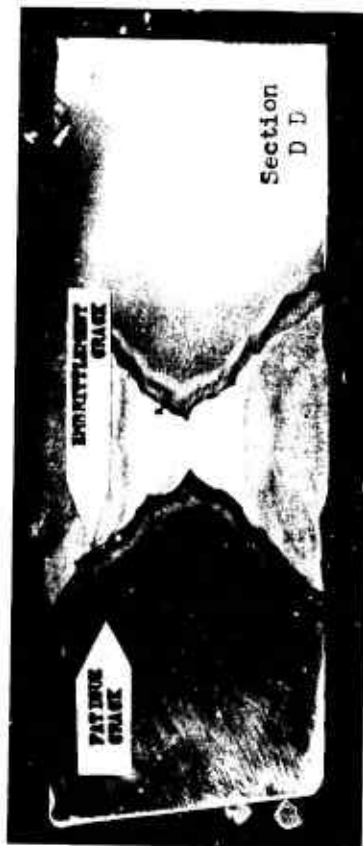
Fig.(6)

10. As indicated in Figure 6 the fatigue cracks initiated at the heat affected zone (toe of weld), propagated through the base plate, but did not approach any embrittled weld metal deposit.

Macrographs of Butt-Weldment L5PEC-2
Showing Brittle and Fatigue Type Cracks
(See Fig.(5))
